Manhole Inspection Summary

Manhole # S17YY_002MH

Insp Date: **3/2/07 11:30 AM**

Location Address: **3504 COTTONWOOD PL**

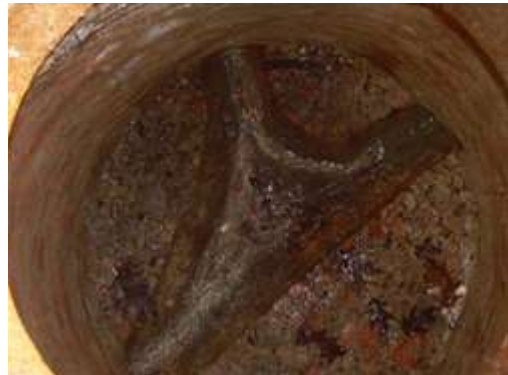
Top View

Evidence of surcharge - Bench debris.

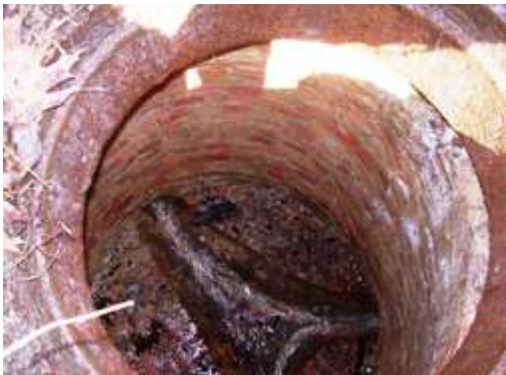
Defect

Frame offset. Frame leaks. Adjustment infiltration

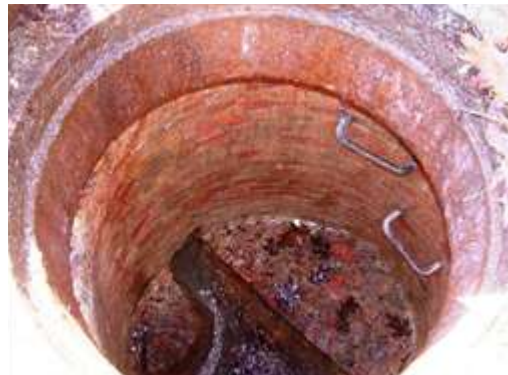
Defect

Frame leaks. Frame offset. Adjustment deterioration and infiltration.

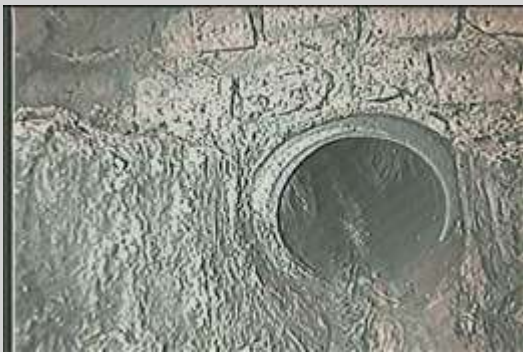
8 in. Circular Gravity Sewer Pipe Out @ 12 O'Clock

Infiltration: **Evidence** Pipe Seal Cond: **Unknown**

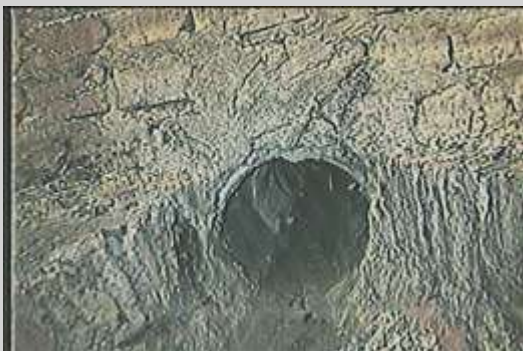
8 in. Circular Gravity Sewer Pipe In @ 2 O'Clock

Barrel deterioration and infiltration. Channel deterioration.

Infiltration: **Evidence** Pipe Seal Cond: **Cracked**

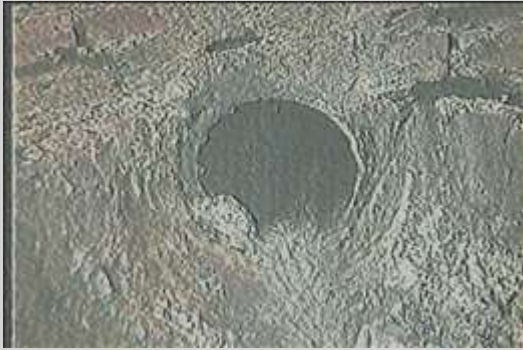
Pipe In @ 7 O'Clock

Infiltration: **Evidence** Pipe Seal Cond: **Unknown**
